# Ugborough Neighbourhood Development Plan

## Conservation Area Character Appraisal

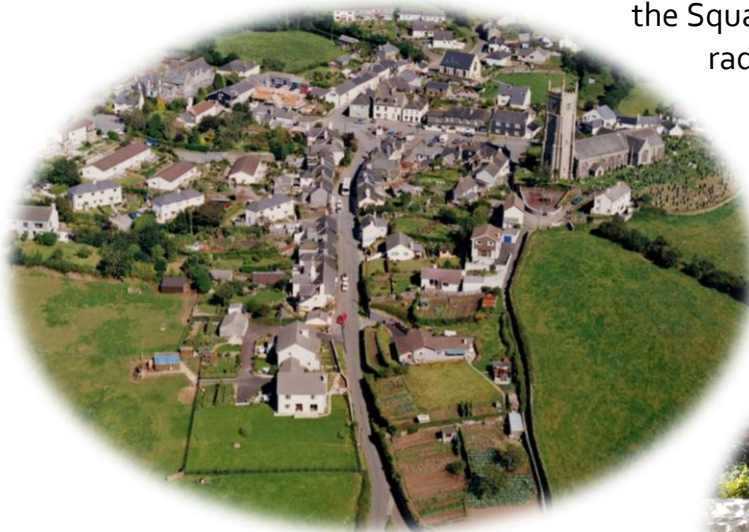
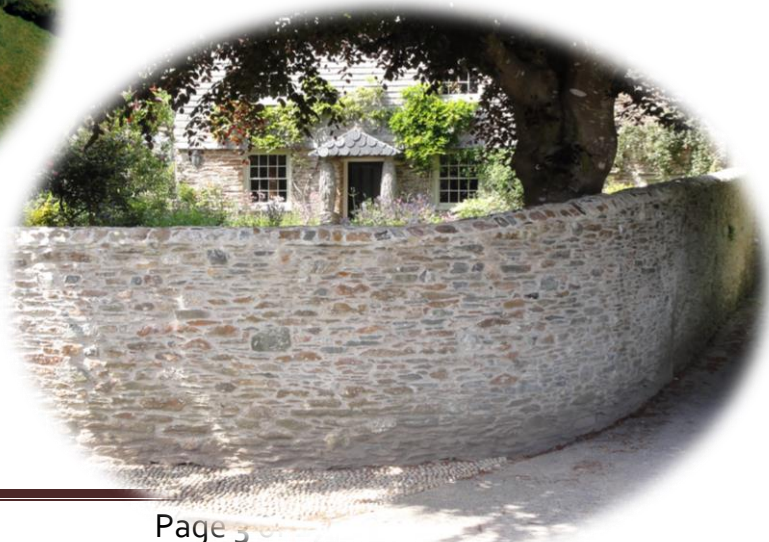
The complex geology around Ugborough is clearly reflected in its stone walls which display

a range of colour and type. The centre of Ugborough village, including the Conservation Area, sits on a dividing line of slate (fine-grained metamorphosed mudstone or shale in which sub-microscopic mica flakes have been strongly orientated by pressure producing typical 'slatey' cleavage and "tuff" (consolidated sediment of volcanic ash).

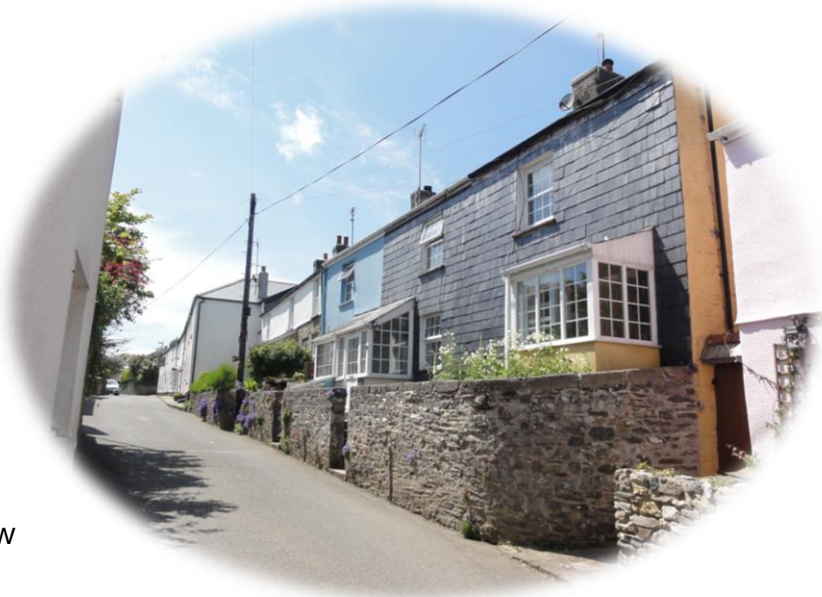
Natural slate is the traditional roofing material, which is locally grey or grey/blue in colour rather than dark. A number of these roofs have been replaced with newer or imitation slate from other sources. Roofs are mostly gabled with a few houses having

hipped roofs. Typically the verges of end gables are plain although a significant number still survive with slates to protect them in the traditional manner. Although dormer windows are not typical of houses in the Conservation Area there are a few houses in the Square where they are evident. These are the only three storey houses in the village.

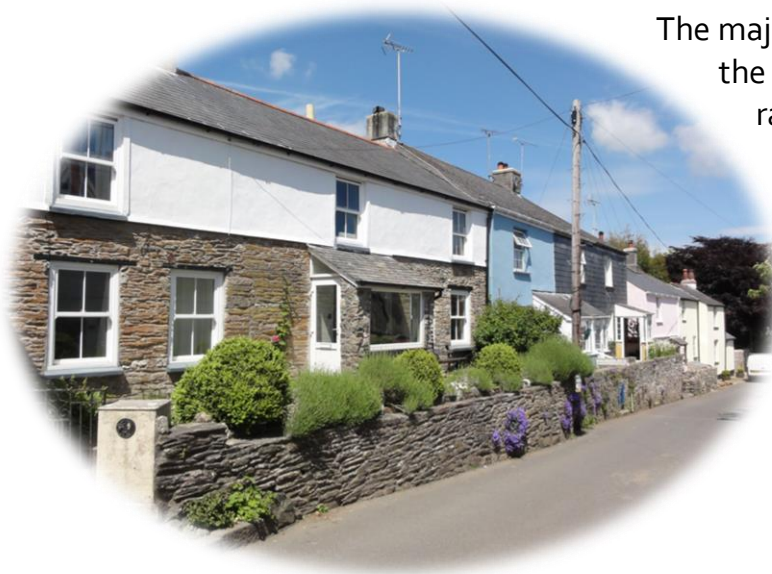
The majority of roof ridges follow the line of the street so that the eaves of the houses, rather than their gables, face forward.

This tends to bring visual order to the street scene particularly where neighbouring building heights are similar as can be seen on the east side of the Square and on the north side of Lutterburn Street.

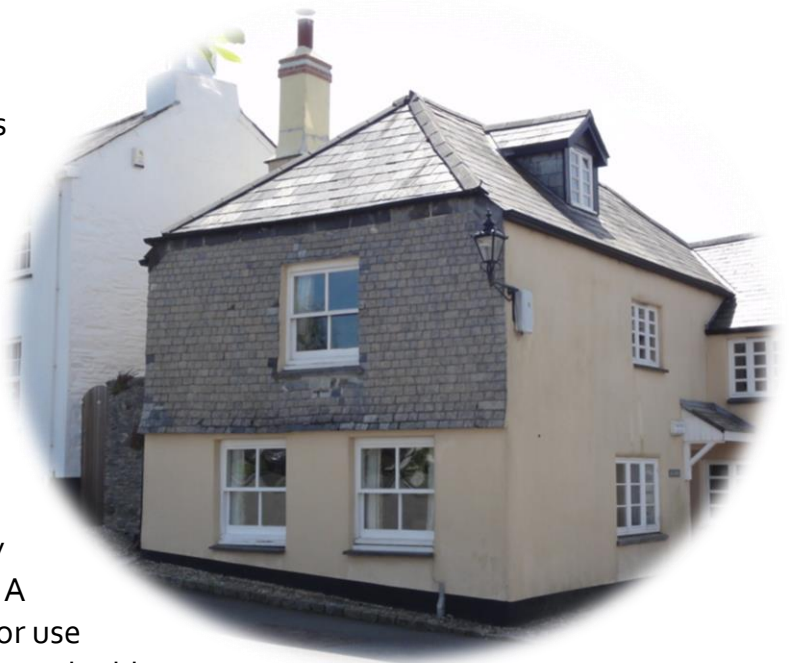
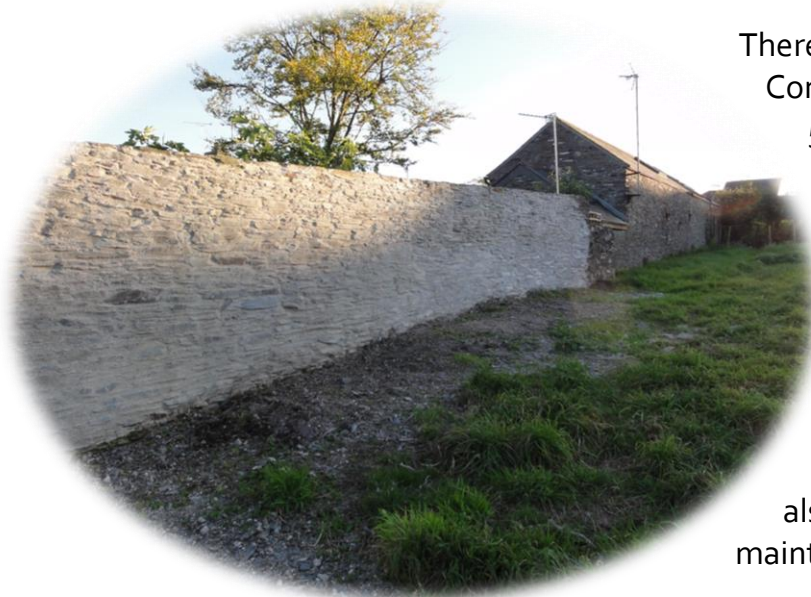
A number of houses in the village have stone built lincays behind the main building. These were originally used to keep livestock, usually pigs. A number have now been converted for use as ancillary accommodation to the main building.

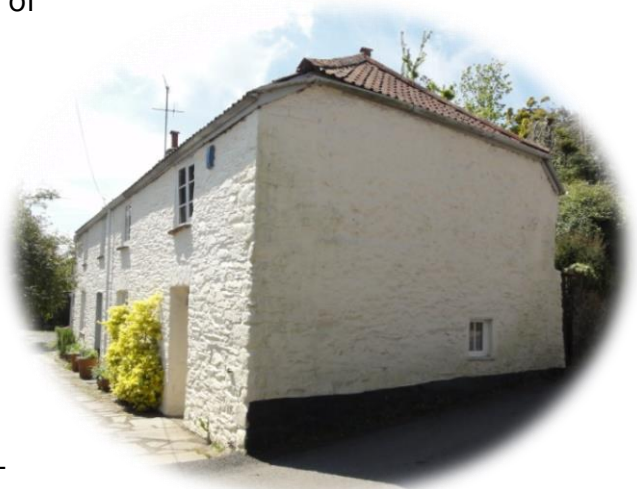
**2. HILL HOUSE INCLUDING CROSS BASE IMMEDIATELY SOUTH.      *Grade II***

House, formerly a village farmhouse. C17 or possibly earlier, remodelled in circa early C19 and restored in circa 1970. Cob refaced in early C19 in stone rubble now whitewashed. Concrete tile roof with gabled and hipped ends. 3 rooms and cross- passage plan. Stack at left hand lower gable end and large lateral stack at centre rear with 2-stair turrets left and right. 2 storeys. 4-window range. Circa early C19 casements with glazing bars, ground floor of 3-lights, first floor 2-lights, all with slate cills, ground floor with flat stone arches. To left of centre cross- passage doorway with C20 glazed door. Right-hand plank door to inner room a later insertion. Interior: Roof largely replaced. Principals at lower end are visible in first floor room. 2 stone newel stairs at rear. Screen at lower side of passage missing, the other screen if it survives is covered in later partition. The 2 rear stair turrets suggests original house had an open hall and therefore probably of early C16 or earlier origin. Including socket stone of large medieval cross in garden which is not the original site. Circa late C14 to C15, granite, square to octagonal, with large cushion-stops slightly keeled.

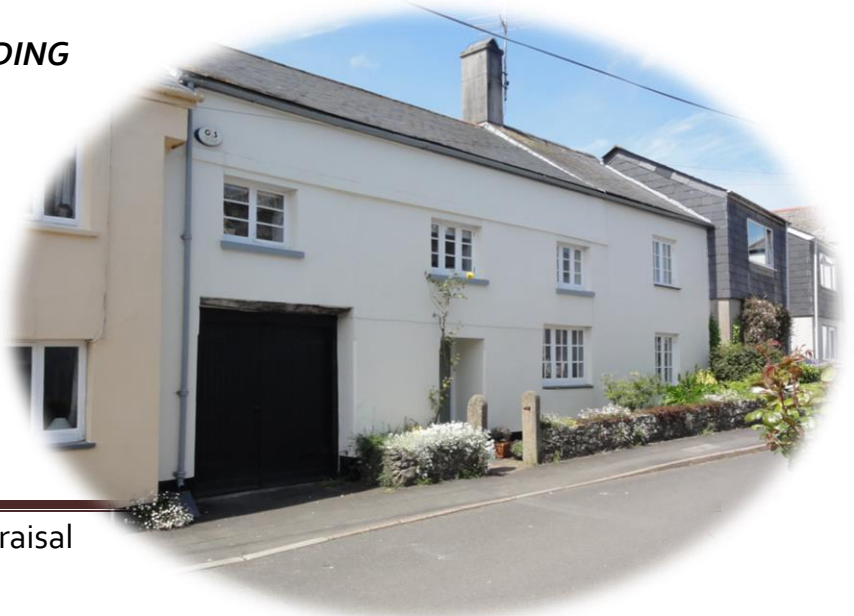
**3. No 4 FORE STREET INCLUDING STABLES IMMEDIATELY WEST.      *Grade II***

House in a row, formerly a cillage farmhouse, and stables. Circa C17 or earlier. Stuccoed stone rubble. Slate roof with gabled end and raised eaves. Originally

probably a 3-room and through or cross passage plan with lateral stack at rear of hall and axial stack to inner room, and with later cartway broken through lower end and later extension at rear. 2 storeys. Irregular 4-window range. Late C19 and C20 2 and 3-light casements with glazing bars. Flush panel door to left of centre. Large cartway to left with boarded double doors and wooden lintel. Interior: chamfered ceiling beams with straight cut steps. Hall fireplace with granite jambs and reset timber lintel with straight cut steps. First floor has 3 C18 fielded panel doors. Roof has principals with halved and side pegged apices and dovetail lap-jointed collars. Trenched purlins, one possibly reused, has smoke-blackening as possibly charring. Including small stable at rear: circa C18, stone rubble and cob with half-hipped scantle slate roof, stable door in end wall with hay loft door above. Linked to house by slate roofed walk supported on large granite posts.

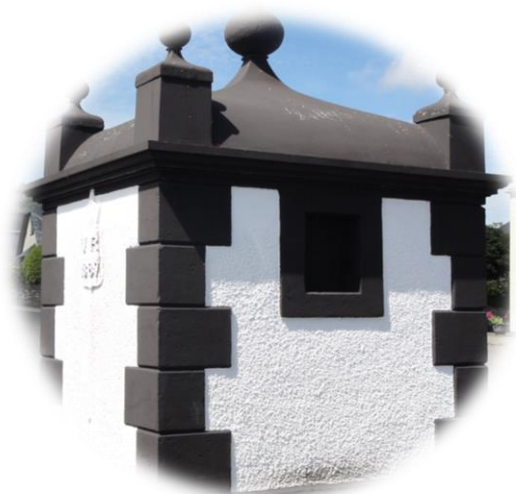
**6. CONDUIT HEAD, THE SQUARE. *Grade II***

Conduit commemorating the Silver Jubilee of Queen Victoria. Dated 1887. Roughcast and with rusticated quoins. Square on plan. Cornice and ogee-shaped roof with bell-finial supporting small fluted iron lamp-standard. Pinnacles of the corners with ogee caps and ball-finials. Small opening on south side. West side has shield bearing VR 1887 with crown over.

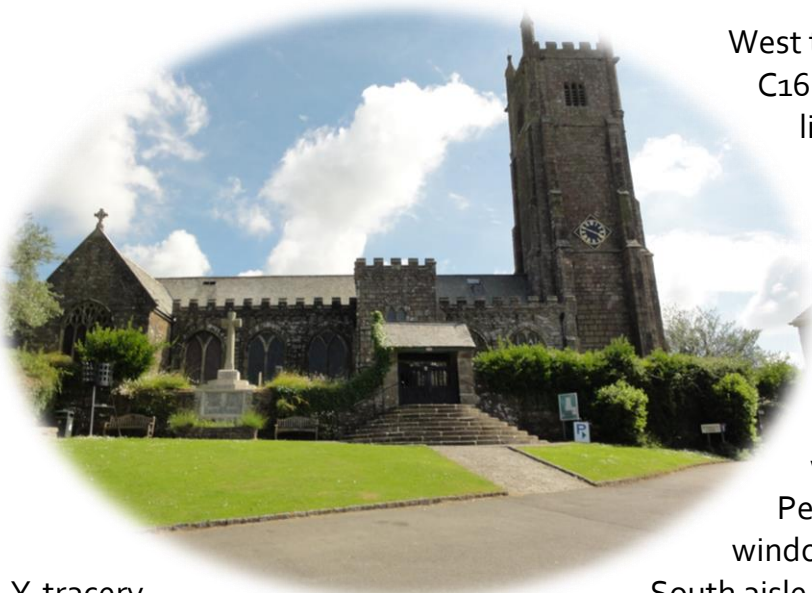
**7. CHURCH OF St. PETER. Grade I**

Parish church, standing on a smaller earlier, earthwork. Early C14 (dedicated in 1311 and 1323). Nave chancel and north and south transepts. C15 north and south aisles, the arcades are C14 though. C15 north and south chancel chapels, north vestry and 2-storeyed north porch.

West tower completed in early C16. Tower rebuilt after lightning struck in 1872 when church was restored by Ashworth. Granite ashlar and coursed rubble and rendered chancel. Slate roofs. The north aisle coursed rubble with corbelled parapet. Perpendicular 4-light windows some replaced with

Y-tracery. embattled parapet with gargoyles and depressed arch perpendicular windows some replaced with Y-tracery. North and south aisles have shallow buttresses with set-offs. Ashlar north and south chapels with embattled parapets, shallow buttresses with set-offs and 4-light perpendicular windows. Priest doorway in buttress on south side of south chapel with gable over. North vestry in chancel chapel angle, ashlar with embattled parapet and canted bay window with 4-centred arch lights. C19 5-light perpendicular sash chancel window. North and south transepts have 4-light perpendicular windows. 2-storeyed north porch with corbelled battlements and stair turret in angle with aisle. Inner doorway has fleurons in the arch and hood mould with head steps. C18 panelled inner and outer doors, the latter with date 1731. Small south porch with chamfered 2-centred arch with sundial above. Very tall west tower (94 ft) in 3 stages, ashlar with setback buttresses with set-offs, battlements, octagonal pinnacles rising from the bottom of the bell style on corbels with carved angels. 3-light bell-openings, 4-light perpendicular west window without hood mould and moulded west doorway. Interior: 6-bay north and south arcades have unusual plain octagonal piers with heeled corbel capitals under the chamfers of the 2-centred arches. The crossing arches and 2 arches of the chapels are C15, 4-centred with monolithic moulded granite piers with carved capitals. Double chamfered tower arch on polygonal piers. Plastered vaulted nave roof. The north aisle roof is flat with moulded ribs, diagonals and large carved bosses - possibly made up front parts of a wagon roof. The transept roofs are late C19 arch-braced collar trusses. The south aisle roof is C20. Piscina in south chapel with unmoulded

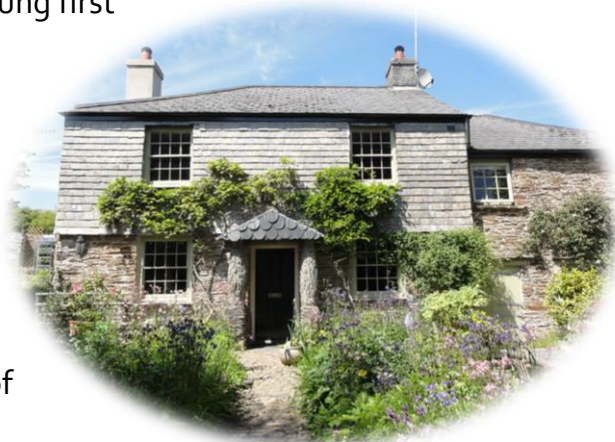
**10. VINE COTTAGE, 21 LUTTERBURN STREET. *Grade II***

Cottage. Circa early C19. Stone rubble slate-hung first floor. Asbestos slate roof with hipped and gabled ends. 2 storeys. 2-window range. Sashes with glazing bars. Central doorway with C20 porch. 2 storey stone rubble one bay part set back to right-hand with lower half-hipped roof, probably originally stables with loft over. External stone steps at rear to loft door. Rendered chimney stacks, one at left-hand end, the other at east gable end of left-hand part.

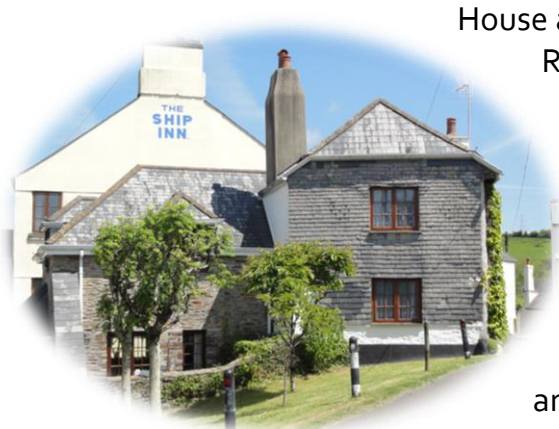
**11. VIRGINIA COTTAGE AND OUT BUILDINGS, ADJOINING NORTH THE SQUARE. Grade II**

House and adjoining cartshed with loft over. Circa C17.

Roughcast stone rubble with slate-hung west end.

Asbestos slate roof with half-hipped ends. Much altered 2-room plan possibly part of larger 3-room house now reduced. Each room heated by large rendered internal lateral stack, one on each side. Rectangular stair projection on north side. 2 storeys. West half hipped gable end slate hung, some of the slates with recessed diamond and heart shapes in diamond and heart shape

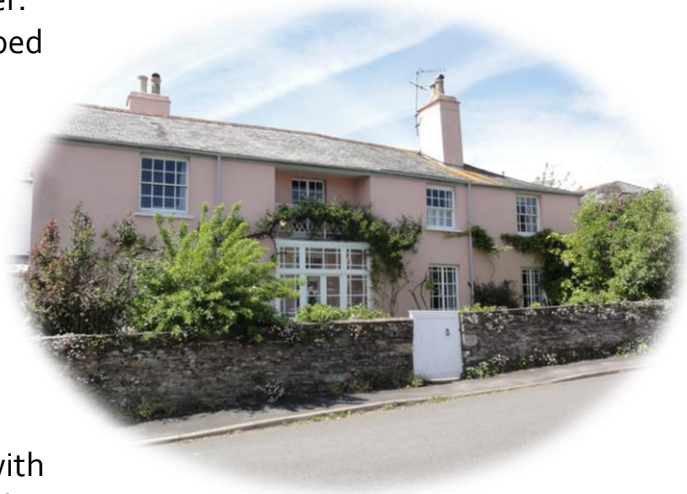
**14. THE MANOR HOUSE, THE SQUARE. Grade II**

House. Early C19 with circa C18 core or earlier. Rendered rubble. Slate roof with gabled hipped ends. 2 storeys. 4-window range. First floor sashes with glazing bars. Ground floor French windows with glazing bars with margin panes. Bay to left of centre recessed with first floor balcony with iron balustrade and French window. Later glazed porch to entrance below. Rendered chimney-stack in front of ridge to right and truncated right-hand end stack. On rear wall now within outshut, 2 C18 2-light windows with leaded panes. Rear wing forming L-shaped plan. Interior: early C19 staircase.

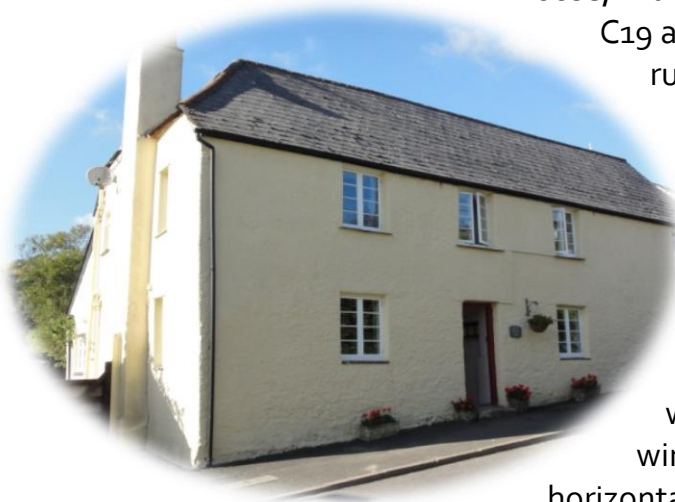
**15. 22 FORE STREET. Grade II**

House, in a row, in village. Circa late C17 with C18, C19 and C20 alterations. Roughcast stone rubble with cob above. Asbestos slate roof with gabled and hipped ends. 3-room and through passage plan with external stack at lower left end. Gabled rear lateral hall stack with set-offs and with gable-ended wing extension with external stairs to loft door. Rear lean-to outshut and C20 wing at rear of lower end. 2 storeys. 4-window range. C19 2-light casements with

horizontal glazing bars. Through passage doorway to left of centre with fielded panel door. Heavy doorframe to rear of through-passage with bead moulding. Interior: hall has 3 moulded ceiling beams with ogee hollow and fillet with run out bar steps. Similar section joists with carved leaf steps. Ceiling beam in lower room moulded on lower side and chamfered other side and with morticed soffit far screen. Former passage has chamfered joists with bar stops and some, probably reused, moulded ceiling joists. Many C18 fielded panel internal doors. Roof has principals halved and side-pegged for the collars and trenched through purlins.

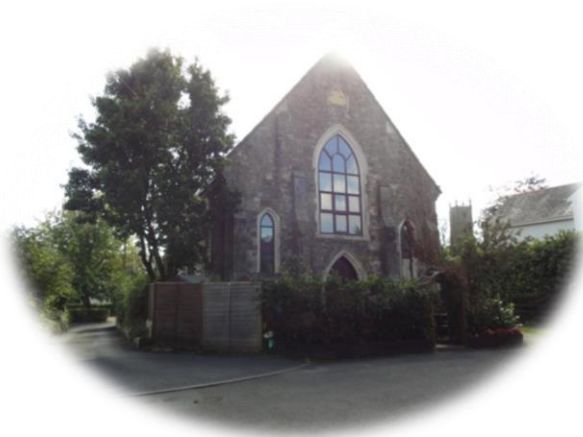
- *Congregational Church, South side of Lutterburn Street, Ugborough. Built in 1851. Date plaque on front wall. Indicated as 'Independent Chapel' on 1906 OS 1:10560 map (CXXV NE) and as 'Congregational Chapel' on 1969 OS 1:10560 map (SX65 NE). 'Independent Chapel Sunday School' indicated on OS 1:2500 map of 1889 (CXXV. 4). Now converted into two dwellings.*

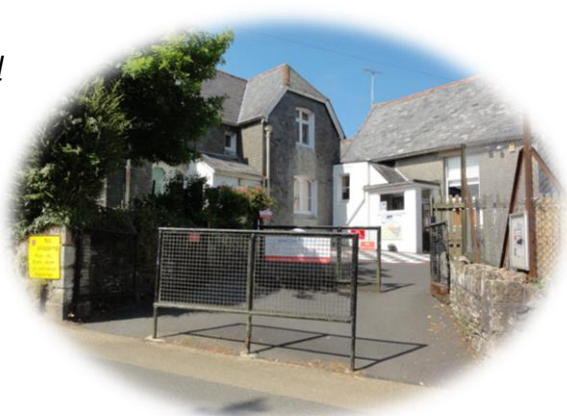
- *Ugborough village school, probably standing on the site of an earlier school building. The present school was opened in 1876. The 1842 Tithe Survey lists as 'near the Anchor Inn' (which is close to the present school), 'a malthouse, school & stable'. 'School' indicated on OS 1:10560 map of 1889*

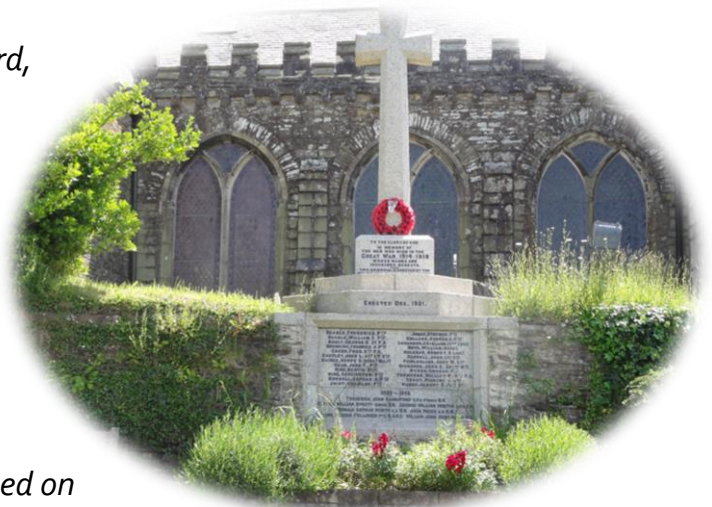
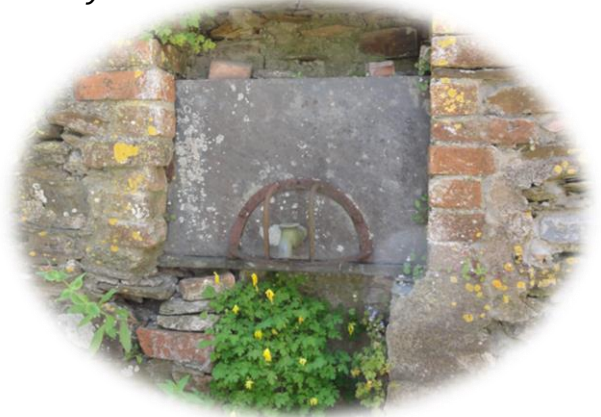
- *On North side of Ugborough Churchyard, facing the Square. Erected 1921. Granite cross with octagonal cross-section stem resting on two octagonal plinths. Plaques for WWI, giving 24 names and ranks, and for WWII with 7 names, ranks and branches of Service.*

- *Disused public water tap, probably originally brass but now plastic, mounted on a rectangular slate tank, width 75cm, mostly buried in the wall outside 'Church View' in Donkey Lane. The tap has an old wrought iron protective grille. Source of water is unknown, perhaps a branch pipe from that to the conduit (UG 166). Indicated 'WT' on OS 1:2500 map of 1906 (CXXV.4). A dot on the map of 1887 at the same point may imply a C19th origin.*
